# DAB-4c/DAB-4s Release Notes

Version 1.35-rc8  
14.04.2026

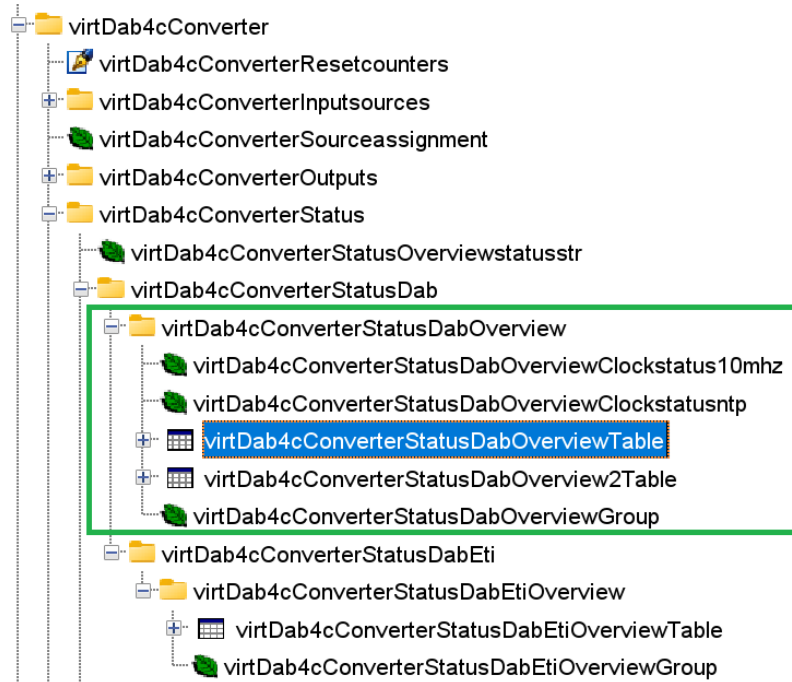
- MIB compatibility was broken in MIB version 2.14

The tables virtDab4cConverterStatusDabOverviewTable and virtDab4cConverterStatusDabOverview2Table had a false position for the OID number. This has been fixed.

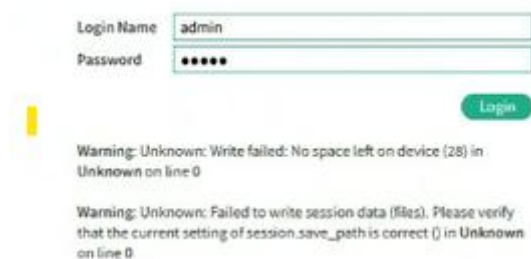
- EDI input “Reordering Depth” set lower than the incoming edi jitter (e.g 24ms or 48ms) led to false missing packets, now only a timeout is monitored and no reset causing missing packets is made.
- Reset Counters for EDI-to-ETI/EDI converter did not work always
- Fix: Login screen might show this entry. This bug is now solved.
