# DAB-4c/DAB-4s Release Notes

Version 1.35.4  
03.03.2026

## Version 1.35.4

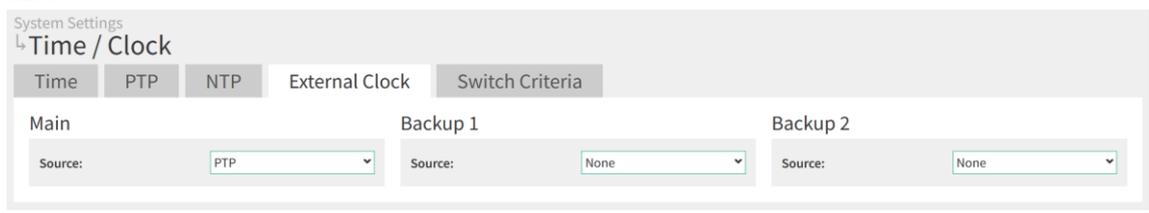
- You still have to configure via the “External Clock” tab (which corresponds to the former “Settings / External Clock” menu), if and which external clock source (PTP, NTP, 10MHz) should be used for the clock synchronization.

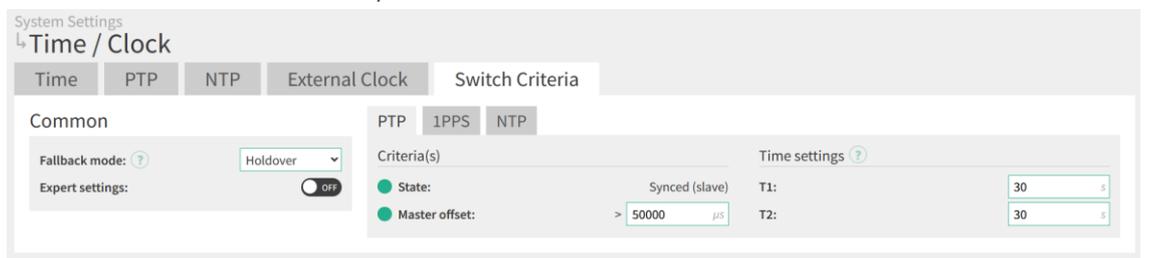
If a backup for the external clock is configured (e. g. NTP), the switch criteria are now configured via the “Switch Criteria” tab of the “Time / Clock” menu.

There’s also a new “Fallback mode” which allows you to control the behavior if all configured external clock sources do fail. In “Holdover” mode (the new default) the device will keep the last external clock (no longer regulated) and will not switch to the internal clock, which would always result in a glitch.

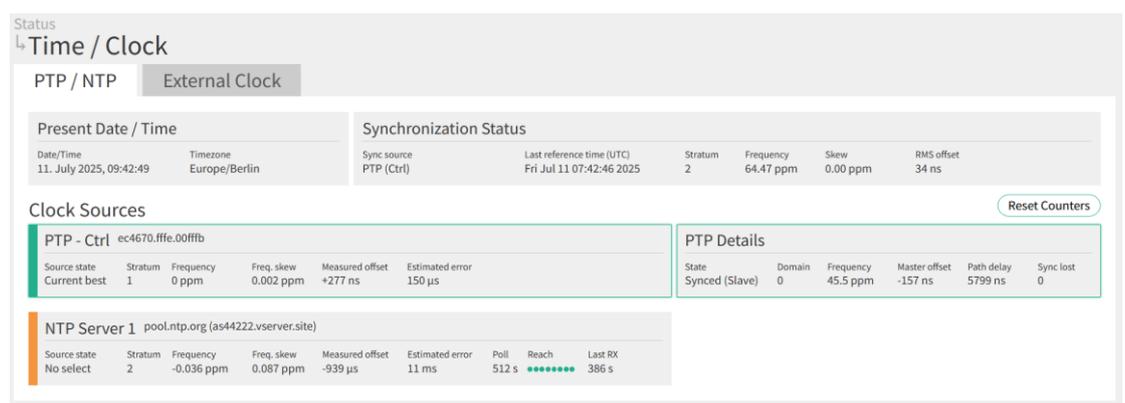
- Together with the revision of the time and clock configuration we did also revise the available status information for time / NTP / PTP / external clock. Before the revision the NTP status could be found via the “Status / NTP” menu, whereas the external clock status could be found on the Overview page in a separate tab. PTP status information was only provided via this “External Clock” tab on the Overview page. The complete status information for all this is now also consolidated into a single place – the menu “Status / Time/Clock”:

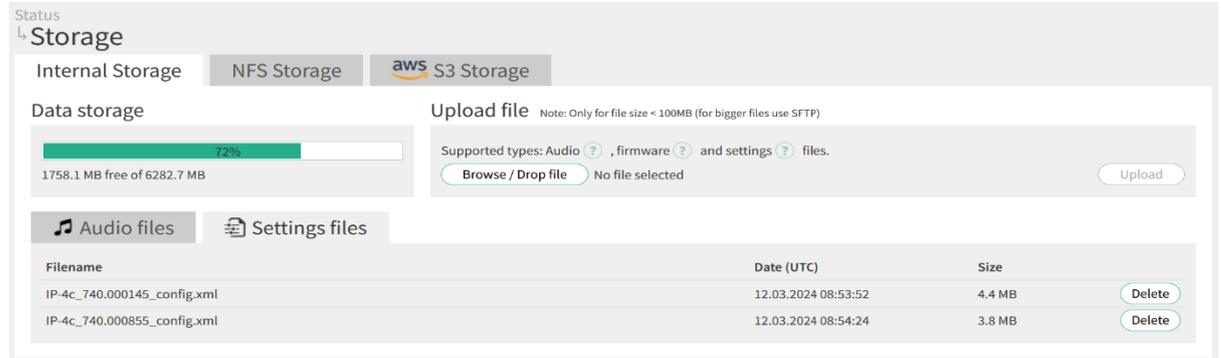
- Settings files can also be uploaded via the Storage page

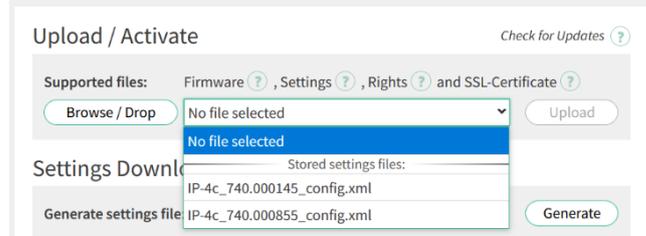
- Once there are settings files on the internal storage the user can select one of the stored files instead of uploading one and load it via the new consolidated Upload/Activate section, thereby having a sort of preset functionality, allowing to quickly switch between different configurations.

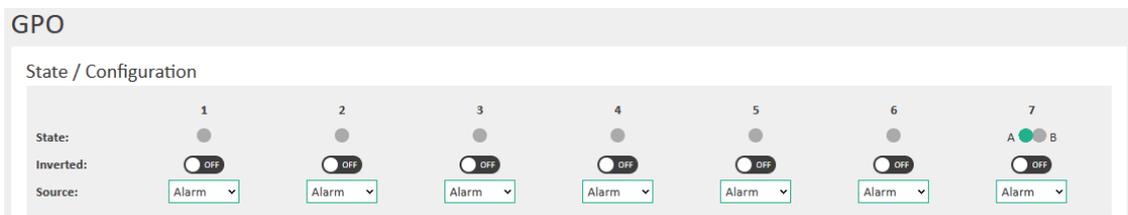
- GPO Output configuration is now compatible to FlexXtract+ GPO configuration. GPO 8 has been dropped. GPO 7 is now an A/B Switch Relais. (Previously GPO 8)  
If FlexXtract+ pinout is needed an adapter cable is now available providing the identical pinning as the FlexXtract+.
