# DAB-4c/DAB-4s Release Notes

Version 1.35.1  
05.12.2025

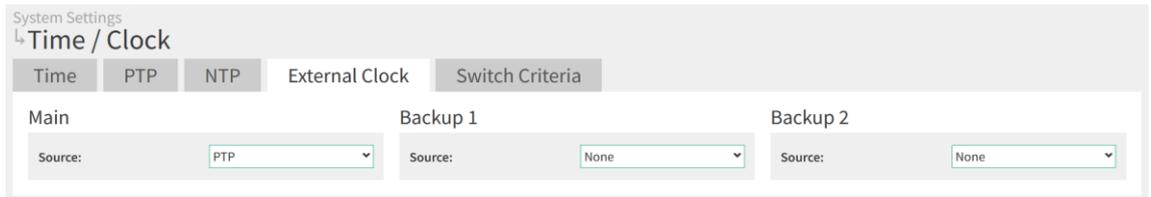
- You still have to configure via the “External Clock” tab (which corresponds to the former “Settings / External Clock” menu), if and which external clock source (PTP, NTP, 10MHz) should be used for the clock synchronization.

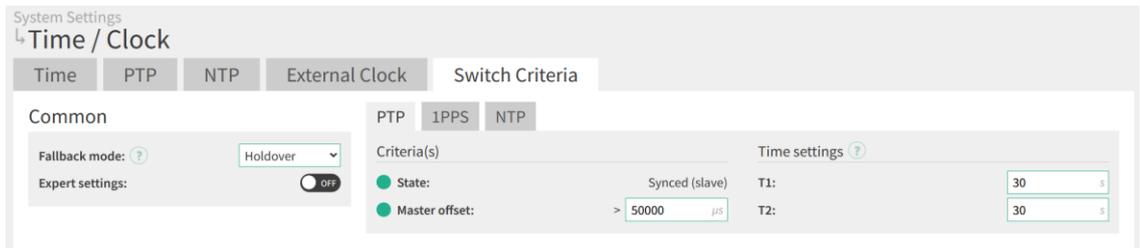
If a backup for the external clock is configured (e. g. NTP), the switch criteria are now configured via the “Switch Criteria” tab of the “Time / Clock” menu.

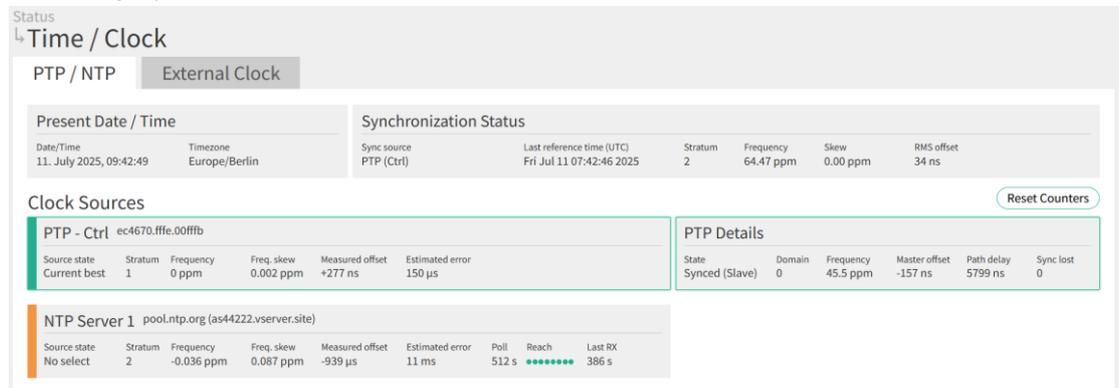
- Together with the revision of the time and clock configuration we did also revise the available status information for time / NTP / PTP / external clock. Before the revision the NTP status could be found via the “Status / NTP” menu, whereas the external clock status could be found on the Overview page in a separate tab. PTP status information was only provided via this “External Clock” tab on the Overview page. The complete status information for all this is now also consolidated into a single place – the menu “Status / Time/Clock”:

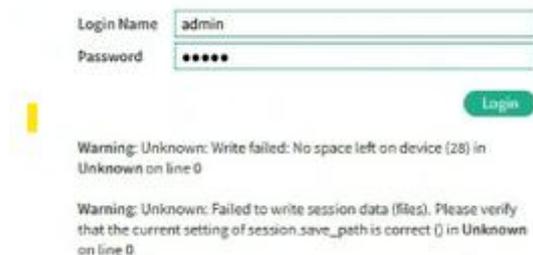
- EDI input “Reordering Depth” set lower than the incoming edi jitter (e.g 24ms or 48ms) led to false missing packets, now only a timeout is monitored and no reset causing missing packets is made.
- Reset Counters for EDI-to-ETI/EDI converter did not work always
- Fix: Login screen might show this entry. This bug is now solved.

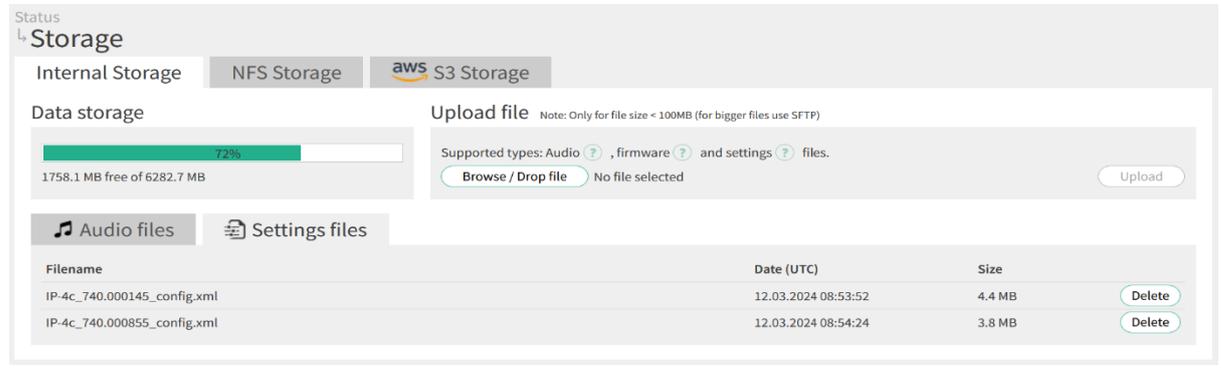
- Settings files can also be uploaded via the Storage page

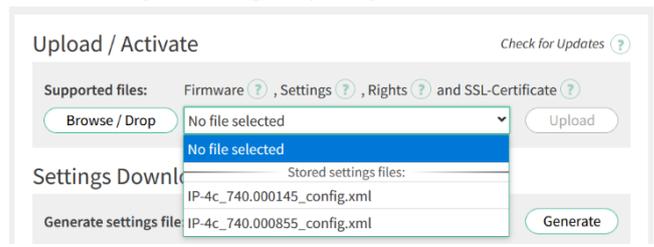
- Once there are settings files on the internal storage the user can select one of the stored files instead of uploading one and load it via the new consolidated Upload/Activate section, thereby having a sort of preset functionality, allowing to quickly switch between different configurations.
