# SAT-4da Release Notes

Version 1.06.5  
23.02.2026

# SAT-4da Release Candidate Notes

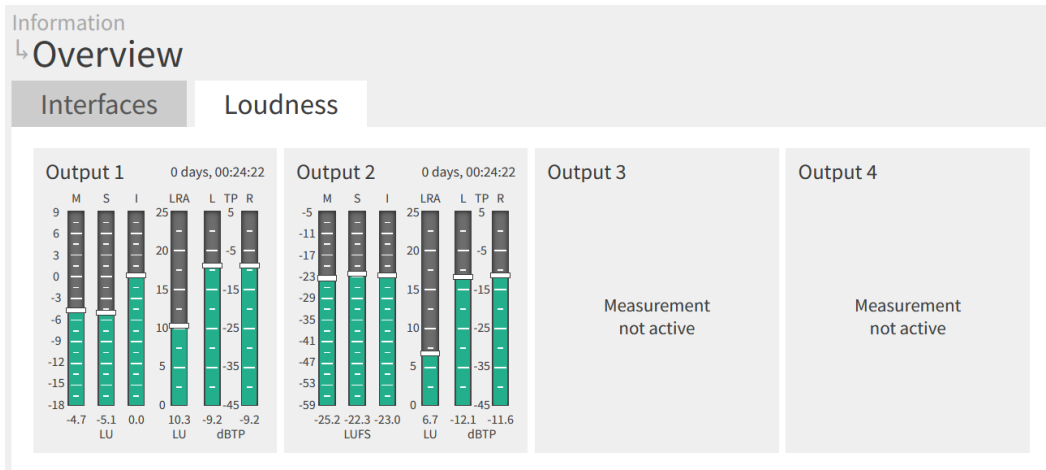
- Added optional Loudness metering/monitoring according to EBU R 128 for the audio outputs

The reference levels and scales can be configured individually via Interface Settings / Audio:

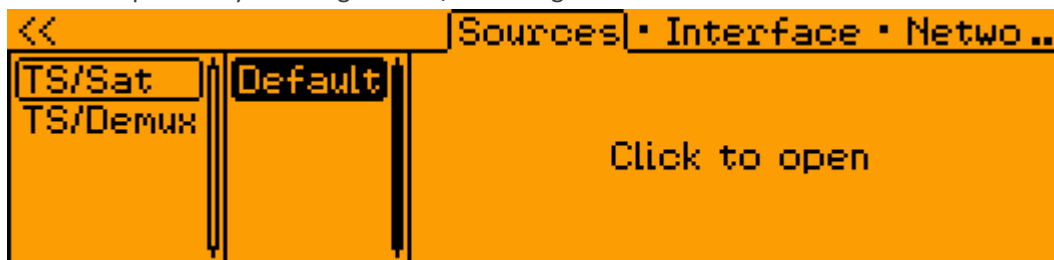
- Added the possibility to change the TS/Sat configuration via the LCD menu
